Restoration
of a
Radiola 60 Radio and RCA 103 Speaker
for the
Bandon Historical Society

August 2015

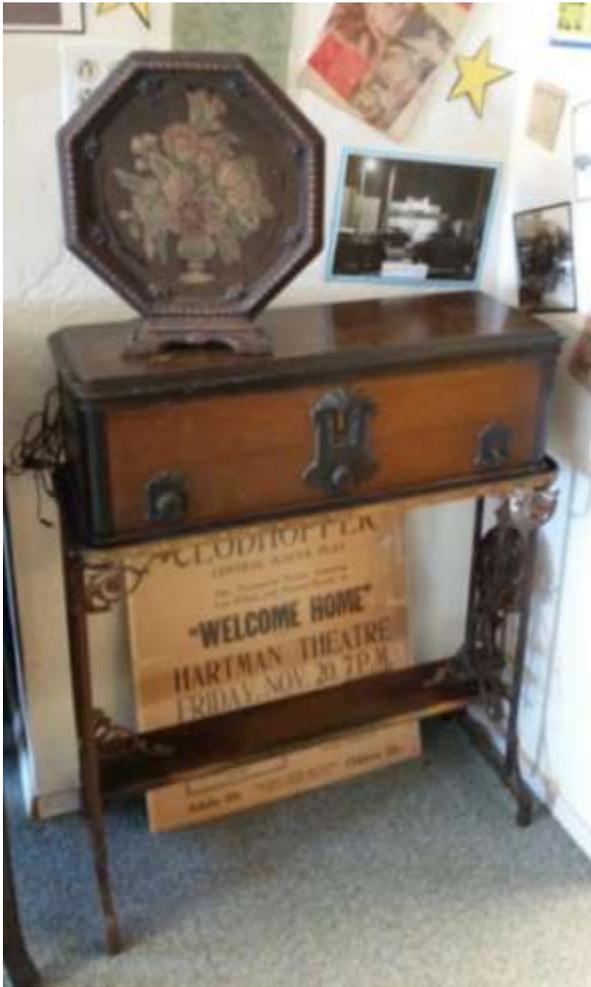
The radio's cabinet was in relatively good condition although the lacquer was cracking, there were water and paint stains on the lid, the color on the front was faded and a small piece of veneer was missing on the top. In addition, someone in the past had drilled 3 holes in the back of the cabinet to provide access to the compensation capacitors on the chassis. I elected not to attempt to fill these holes.

Radiola 60 with 103 Speaker unrestored

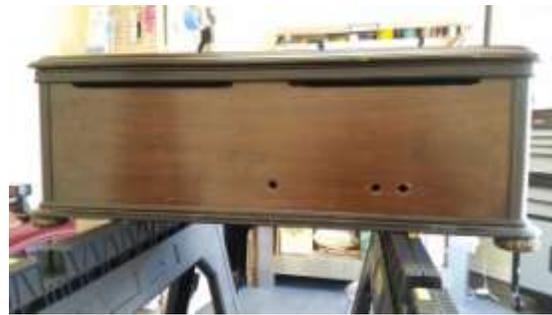
Back of radio

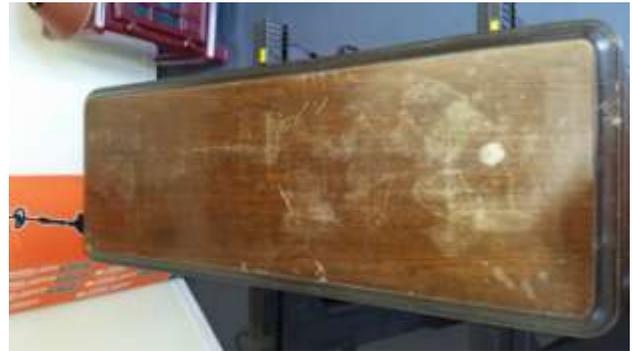
Top of the radio lid

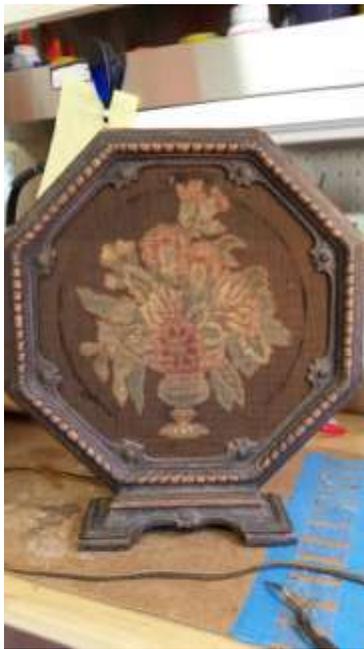
The speaker's grill cloth was extremely fragile and was torn in the circle around the edge of the speaker cone. Since the objective was to play the radio on a regular basis, this cloth would not hold up over the long term and a reproduction replacement was purchased and installed. The frame of the speaker was made with a material that was called repwood which was a mixture of sawdust and glue that was molded into the desired shape. The frame was cleaned with damp cotton swabs and a light clear lacquer coating was applied. The original silk bonnet that was used to keep dust out of the back of the speaker was missing except for a small piece seen below, thus a replacement was obtained and installed. The wires that connect the speaker to the radio were badly frayed and also replaced.

Original Speaker

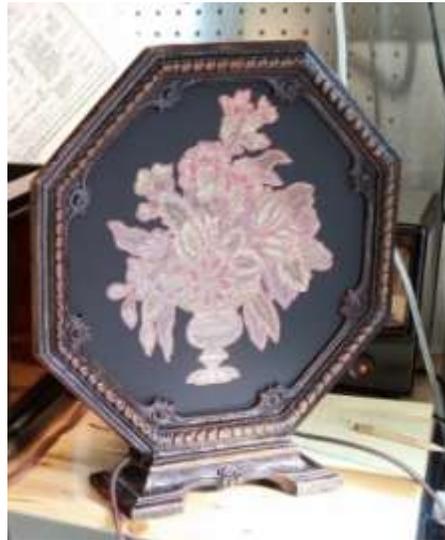
Restored Speaker

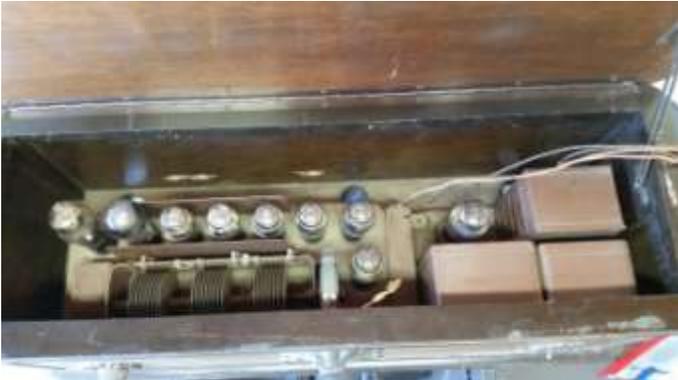
Electronics before restoration

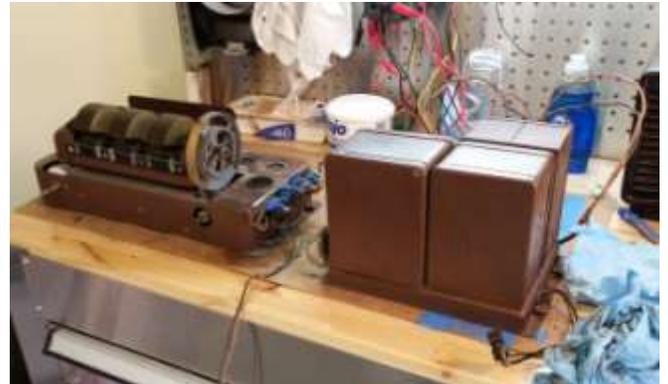
The electronics are contained in two chassis sections, one for the supply of power and the second for the remaining components. They are connected by a terminal strip and wires found under a cover plate.

Electronics out of the cabinet

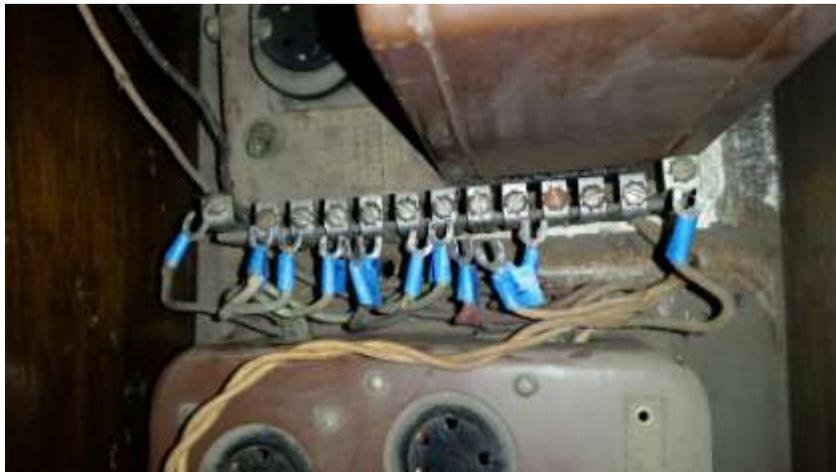
Connecting Terminal Strip

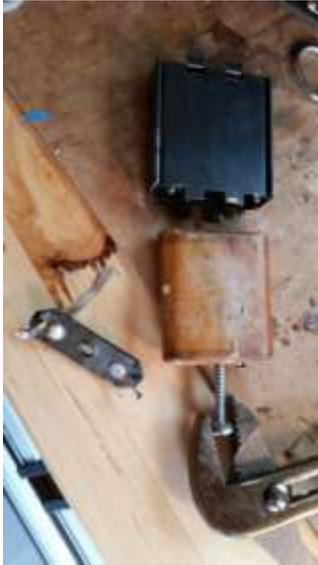
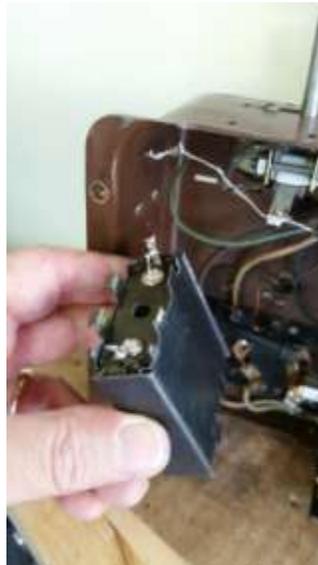
There were also two by-pass filter cans that needed the capacitors replaced.

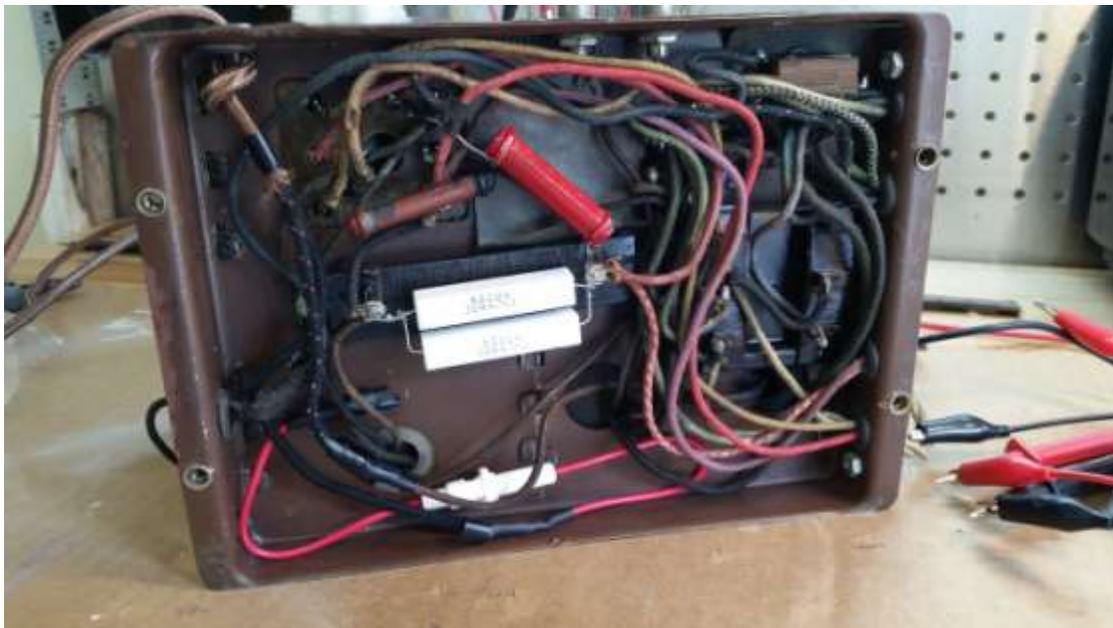
Plate Resistor Repair and Fuse Added

The 2250 ohm wire-wound plate resistor was open and replaced with two parallel 4700 ohm 10 watt wire-wound resistors. The parallel resistors yield a 20 watt 2350 ohm resistor. Close enough in resistance and overkill in wattage. A 1.5 amp fast blow fuse was inserted into the new reproduction cloth covered power cord line for safety. I kept it in under the chassis for appearance although this will require the power supply to be pulled from the cabinet for replacement.

The original Plate Resistor was left in place and the wire lugs used for the replacement resistors. It may be possible to rewind the original at some future date. Other resistors were checked and found to be within 20% of the specified values so they were not replaced.
